HOT DESTRUCT TEST OF THE THIRD-STAGE ATHENA/H SOLID ROCKET MOTOR

TECHNICAL REPORT AFRPL-TR-71-116

NOVEMBER 1971

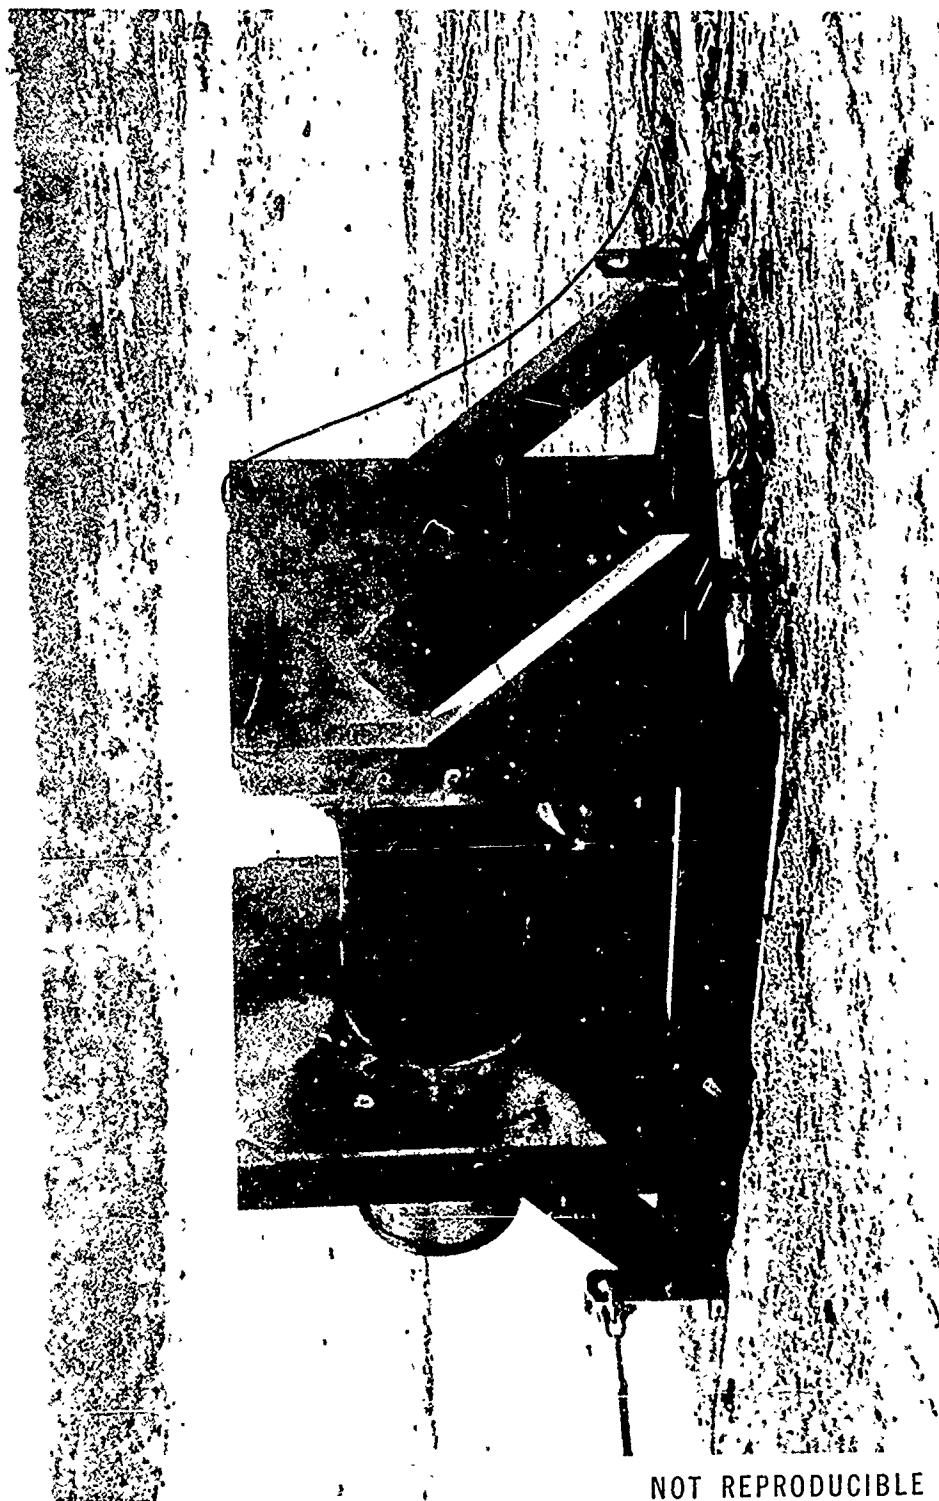
Figure 1. Post-test View of Stand

as a result of propellant burning at ambient pressures. These flames melted approximately half the case (Figure 1).^{*} The maximum radius of debris was 700 feet (debris was recovered to a 450-foot radius).

The destruct test successfully terminated the thrust of the Alcor IB motor as programmed. The pressure switches actuated on ignition, permitting the destruct signal to activate the destruct system 7.5 seconds after motor ignition. Upon command destruct, the motor case ruptured along the length of the LSC, the adjacent propellant ignited, a 1-pound piece of the forward dome blew off, and the motor thrust terminated. After the relatively nonviolent destruct, the motor remained basically intact. However, flames were observed through the slot in the side of the case, the forward dome and nozzle for 100 seconds after command destruct

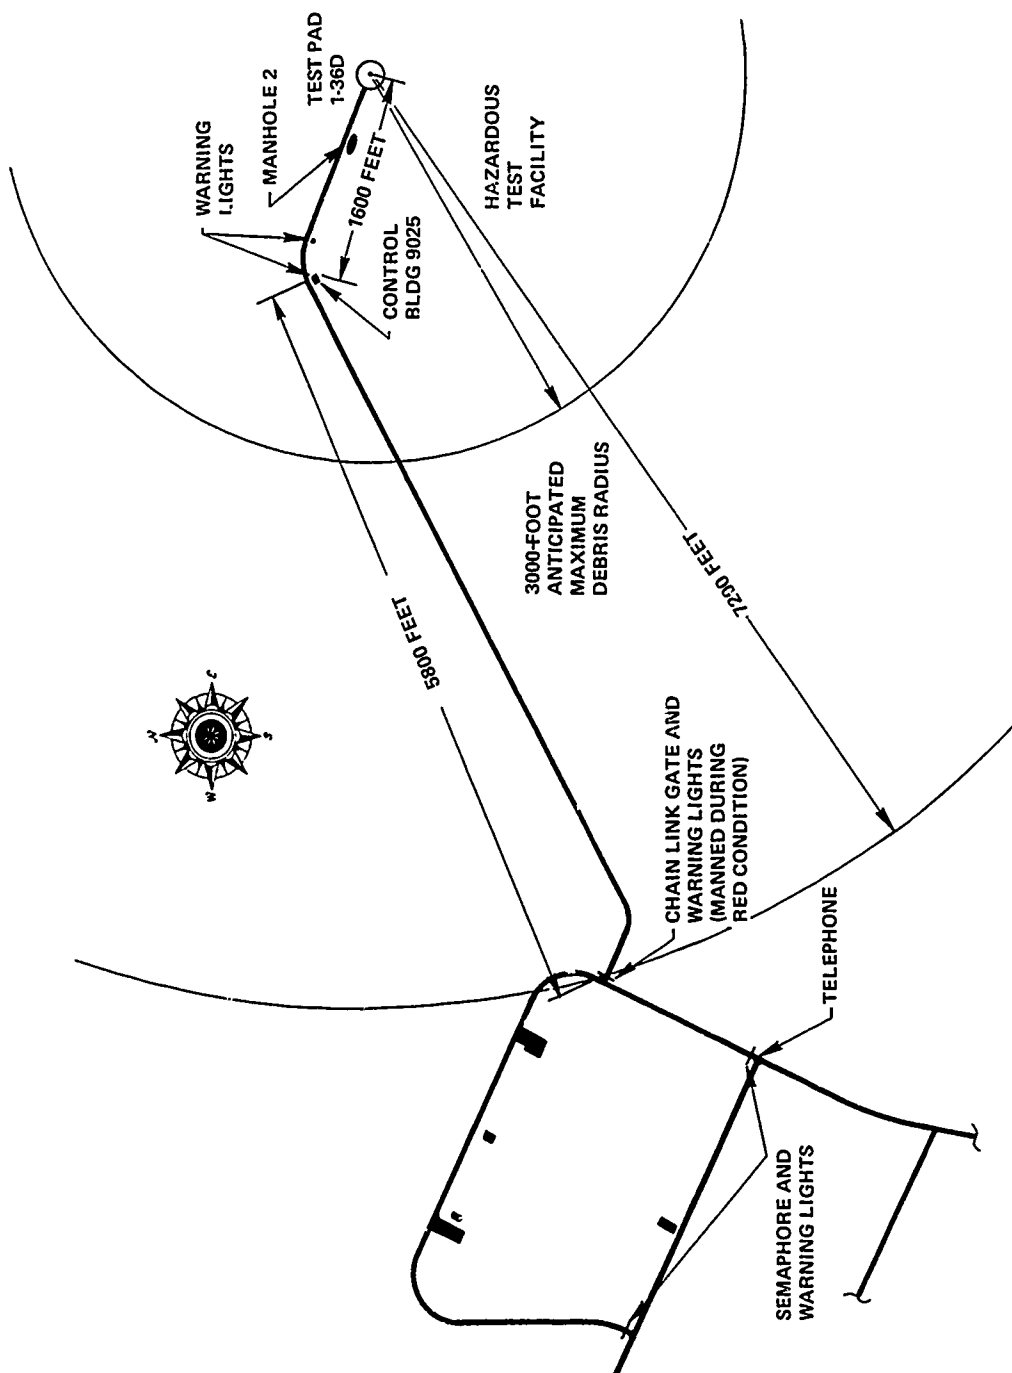
Figure 2. Layout Schematic of Test Area

The Athena Destruct Test was conducted at Test Area 1-36D, a remote blast hazards area sited for 1-million pounds of TNT. The test pad is located 2750 feet above sea level in a shallow valley; the surrounding terrain rises to an altitude of 2800 feet above sea level at a distance of 1000 feet from the test pad. Figure 2 is a schematic of the general layout of Test Area 1-36D.

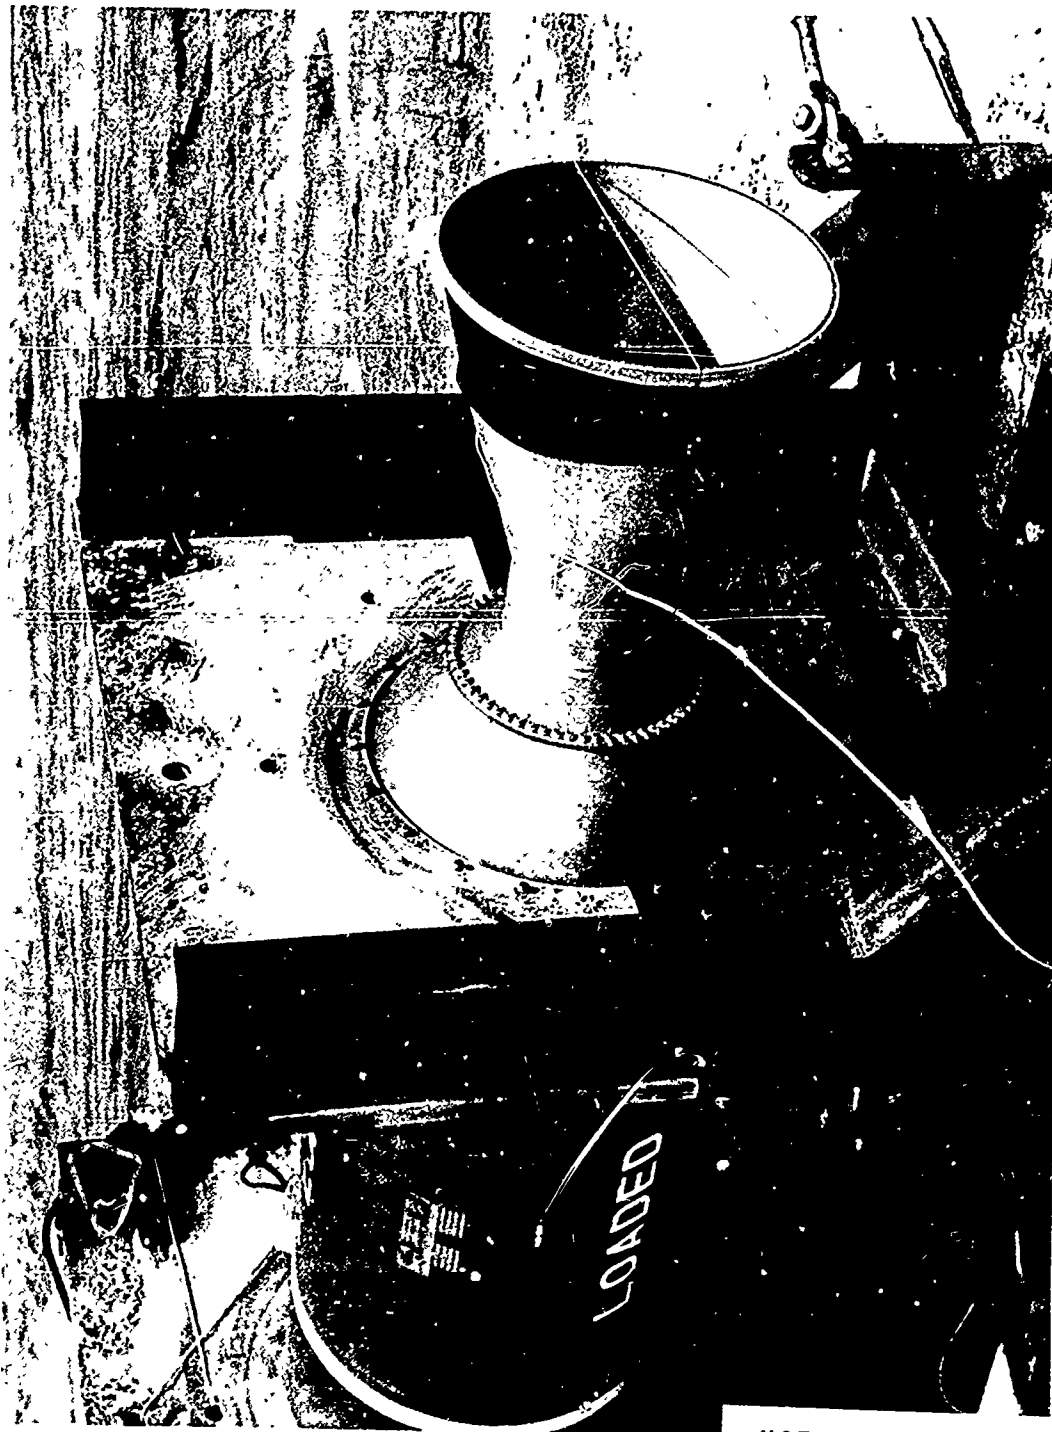
Figure 4. Pre-test View of Nozzle

Motor chamber pressure was redundantly monitored with two 1000 psi pressure transducers. Initial motor thrust was monitored by a breakwire secured across the nozzle exit cone (Figure 4). The initiation and magnitude of the igniter and safe and arm currents were monitored and recorded. The initial activations of the Fastax cameras were recorded.

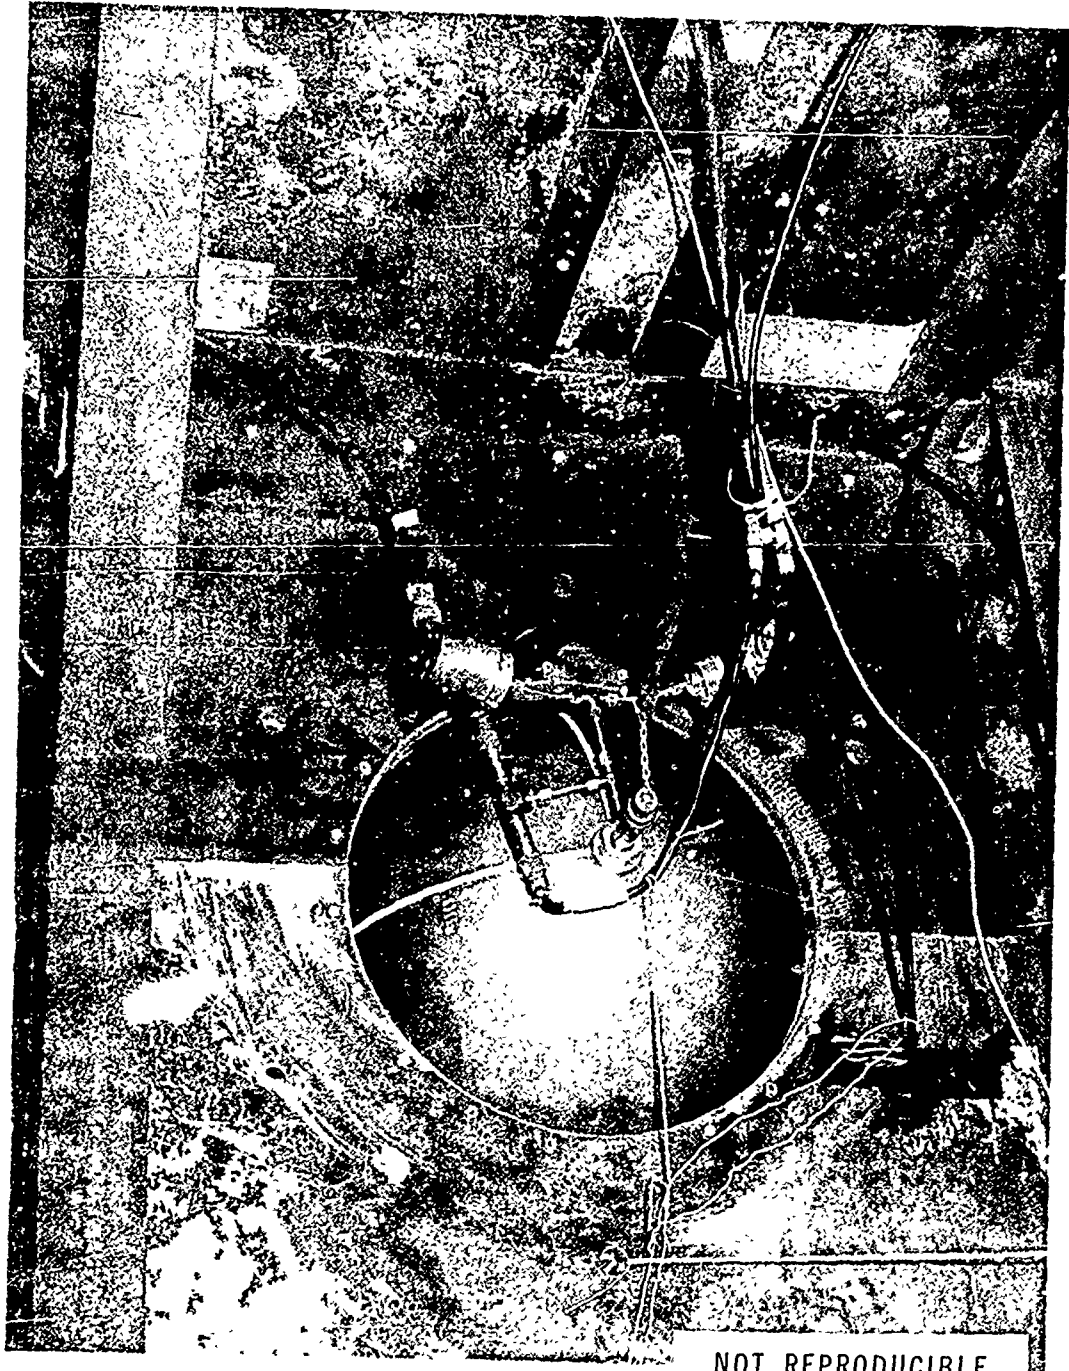
Figure 5. Pressure Switches

Two pressure switches manufactured by Custom Components, Inc., were electrically connected in series with the destruct ordnance circuit (Figure 5). They were set to actuate, thereby completing continuity of the destruct circuit, when motor chamber pressure increased to 165 ± 5 psi. An automatic override switch was programmed as a backup system to complete the destruct circuit 0.4 second after initiation of the destruct pulse.*

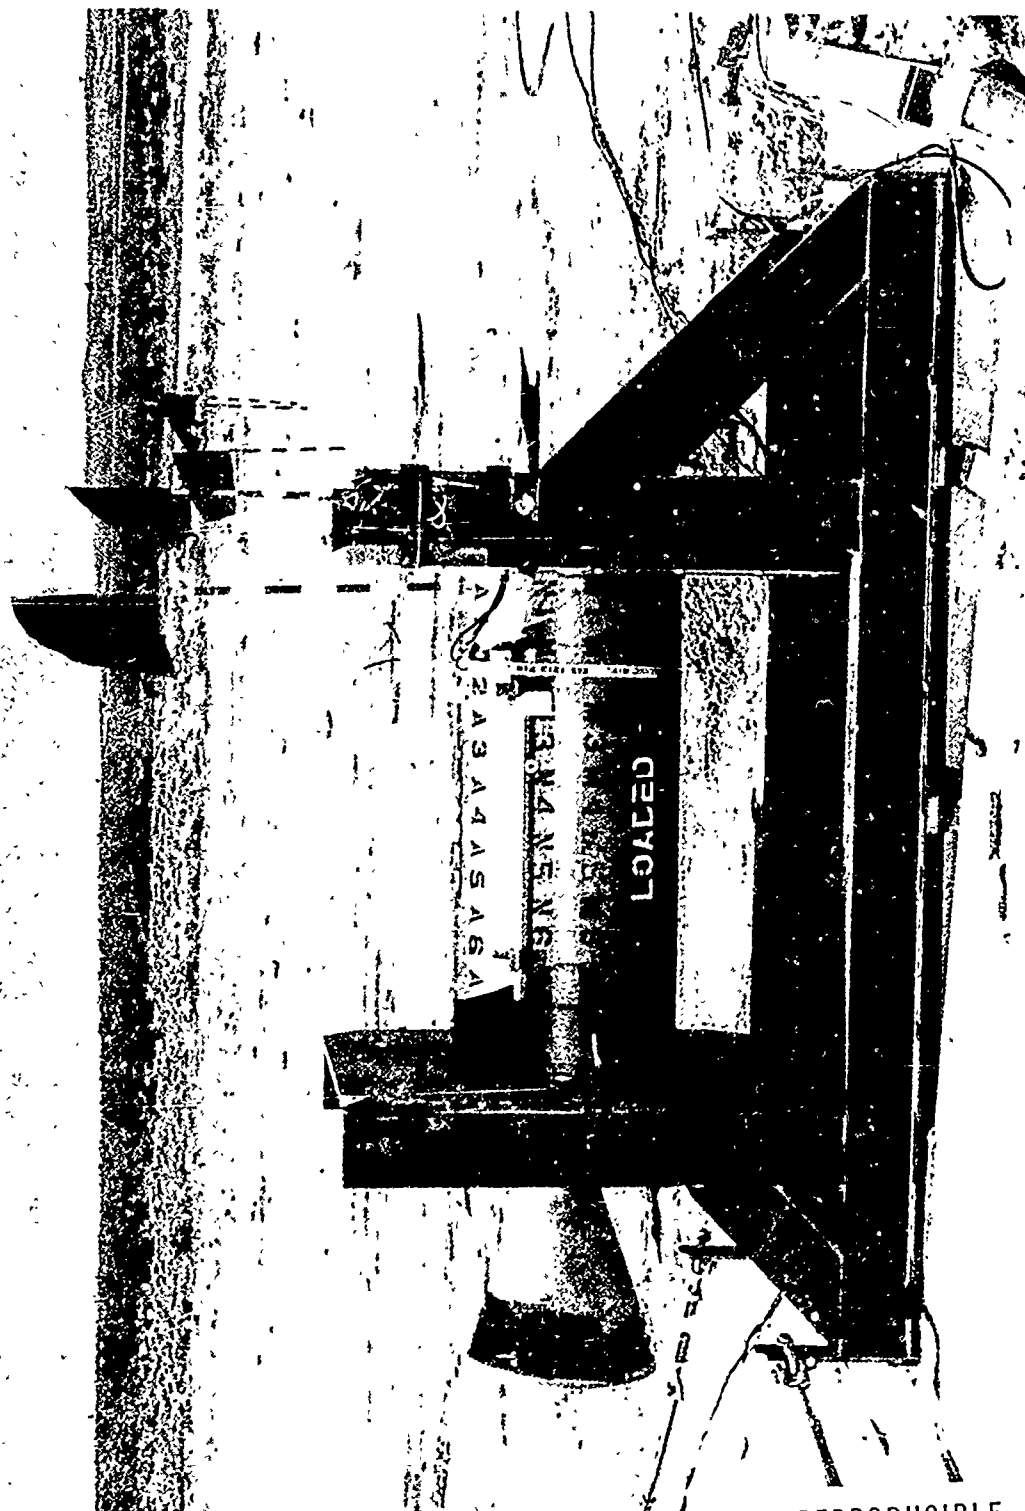
Figure 6. Pre-test Motor View

The operational Alcor motor was horizontally restrained and secured to the test stand at the forward and aft interface skirts (Figure 6). The linear shaped charge (LSC) and the detonation transfer block were bonded to the motor. The safe and arm device was bolted to the det block and restrained further with a nylon strap that was wrapped around the motor and over the safe and arm device (Figures 7 and 8).

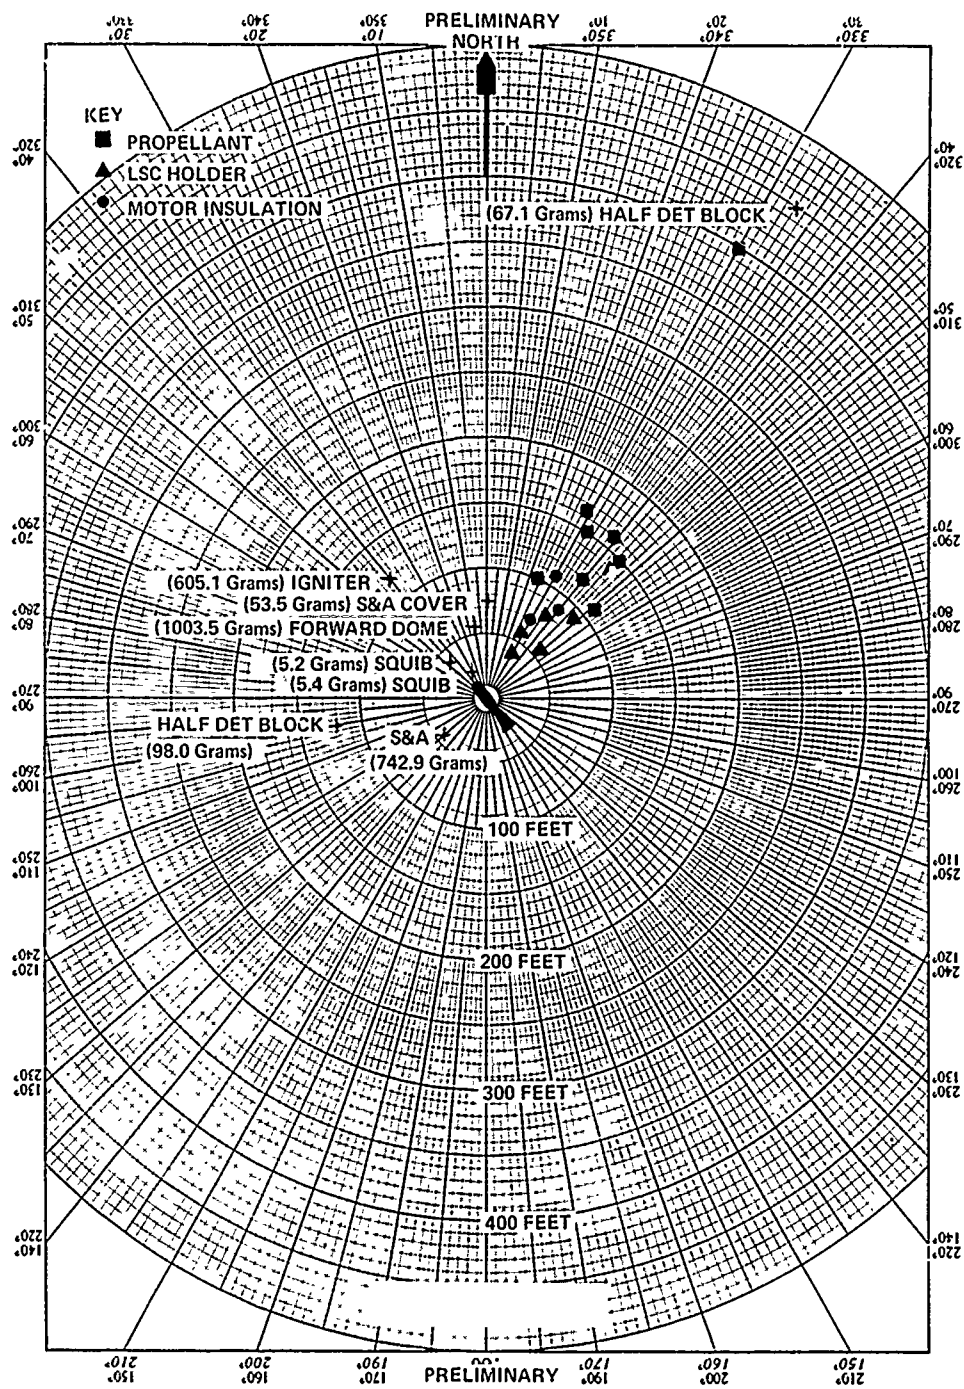
Figure 10. Debris Map

The maximum radius of debris which was recovered was approximately 450 feet. Figure 10 is a map of the debris location and weights.
